Four Hills Speed Hump Evaluation Study

Albuquerque, New Mexico

Michael J. Cunneen

July 2007

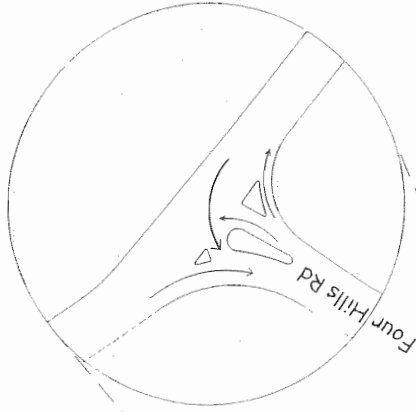
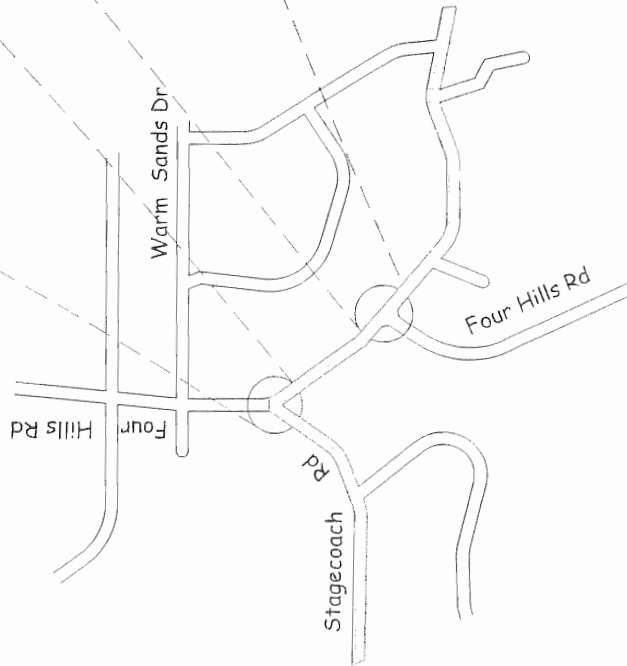
North Intersection

1. Extend west sidewalk, Four Hills Road, through intersection
2. Arrow signs & painted arrows on pavement to delineate inbound left turn movement
3. "Merge" arrow signs to warn inbound left turn of merge with inbound right turns

South Intersection

1. Trim bushes on SE triangle for better view to/from NB left turn
2. Arrow signs & painted arrows on pavement to delineate inbound left turn movement
3. "No Entry" sign on SE triangle to ward off inbound left turns into outbound left turn lane
4. "Merge" arrow signs to warn inbound left turn of merge with inbound right turns

Figure 7 shows these recommendations over the entire Four Hills area. Figure 8 shows intersection-specific recommendations for the two intersections of Four Hills Road with Stagecoach Road.
